# SNAGGING INSPECTION

1 Levels View, Rowley Road, Glastonbury BA6 8HY

DATE OF INSPECTION: 16<sup>th</sup> November 2022

REFERENCE NUMBER: 7468W

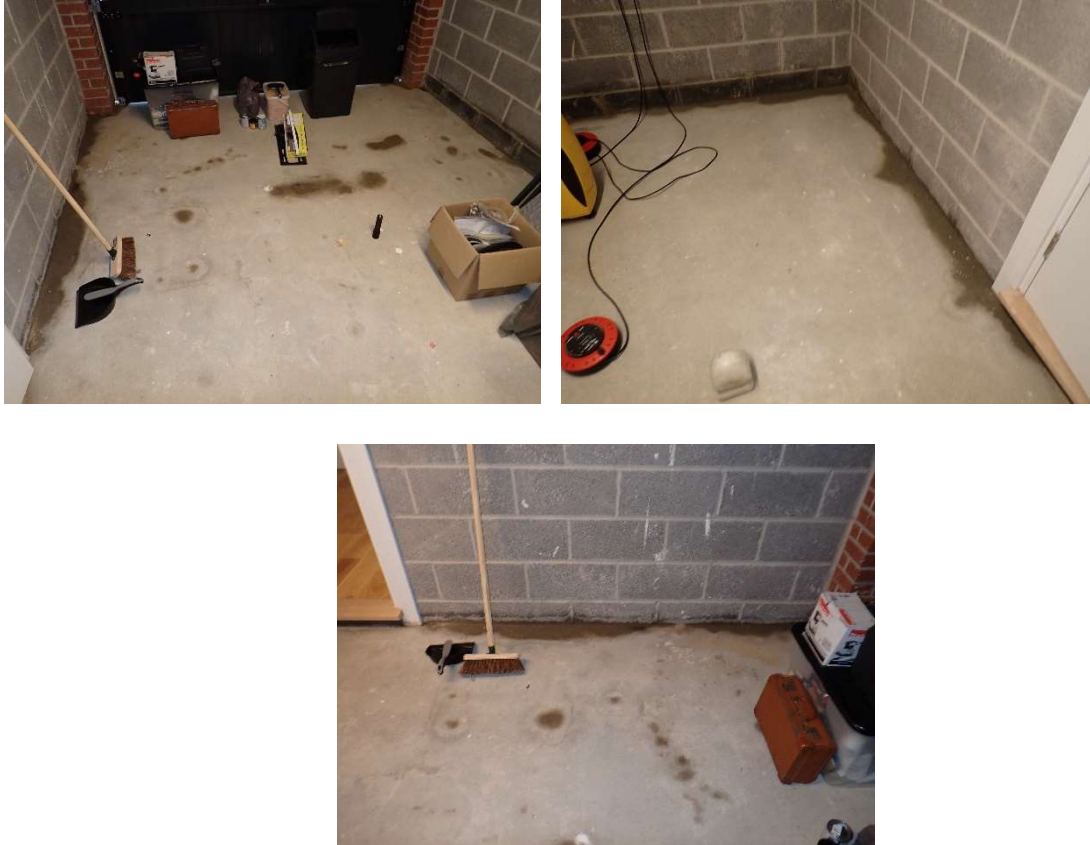
Defective construction is affecting the ground floor. This is most readily visible in the Garage due to the structure being exposed. The internal leaf of the Garage blockwork walls and the concrete screeded floor are visibly affected by dampness.

*Visible affects of dampness round the perimeter of the Garage*

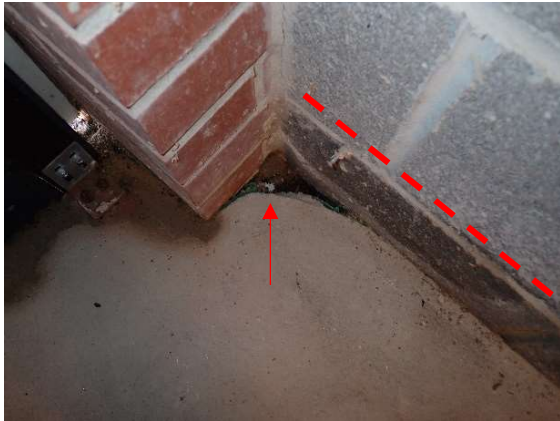
However, the concrete slab appears to have been laid at the same level as the external ground, with no apparent lapping of the damp proof membrane in the floor with the damp proof course in the wall. This is causing penetrating dampness to occur, affecting wall, floor and internal finishes to the habitable areas on the ground floor.

*Floor dpm not lapped with wall (red arrow)  
Red dotted line shows level of wall dpc.*

This visible defect raises suspicion that the relationship of floor and ground levels and poor and lack of damp roofing detailing will be found across the whole ground floor. It is advised to invasively inspect those areas which shows signs of dampness to confirm if similar problems are occurring.

It is suspected that a comprehensive scheme of works to address the problems found will be required. The design to adequately damp proof, reinstate insulation and slab and retain a step down into the Garage will be limited by the reinforced raft foundation below and must be considered before any works commence.

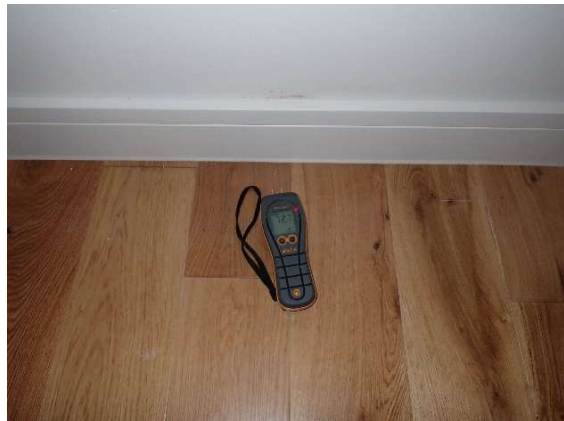
*Deterioration and high levels of moisture on partition*

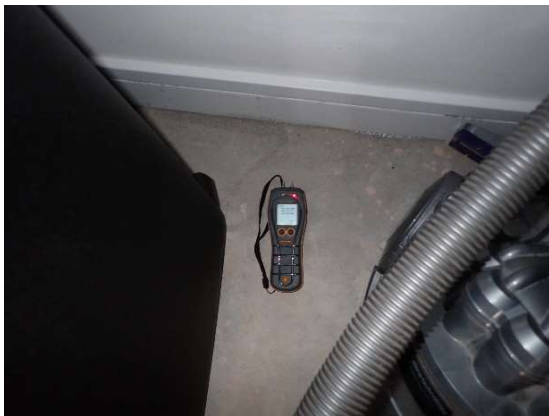
*High moisture understairs cupboard*

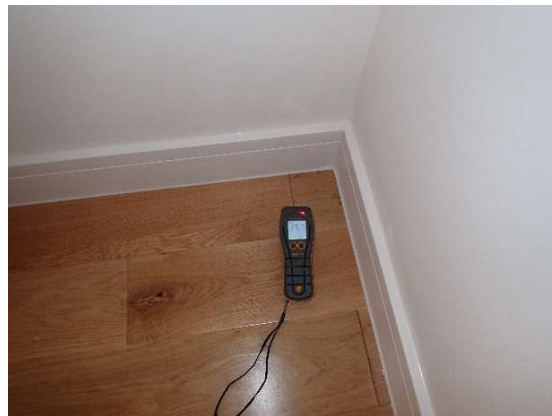
*High moisture Study wall*

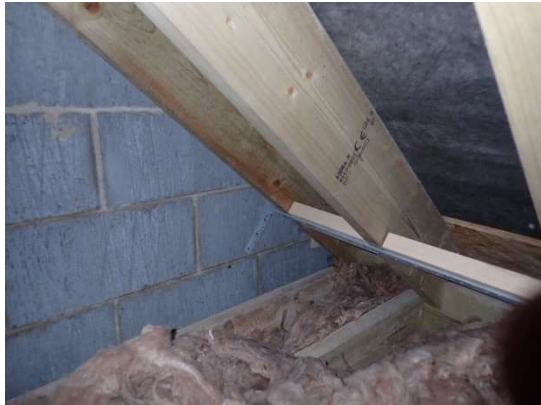
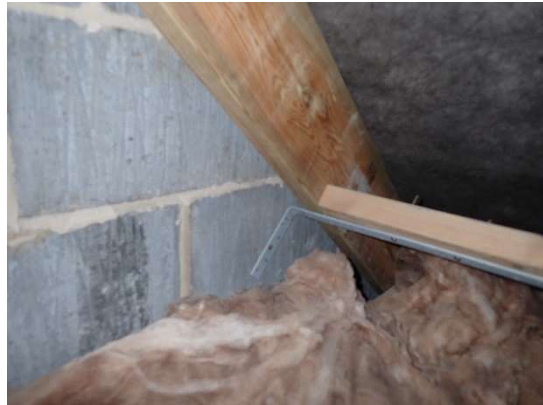
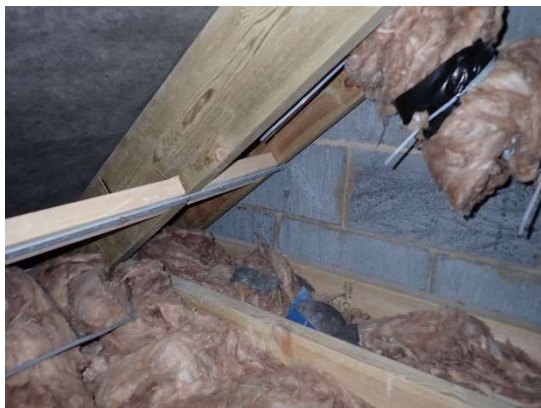
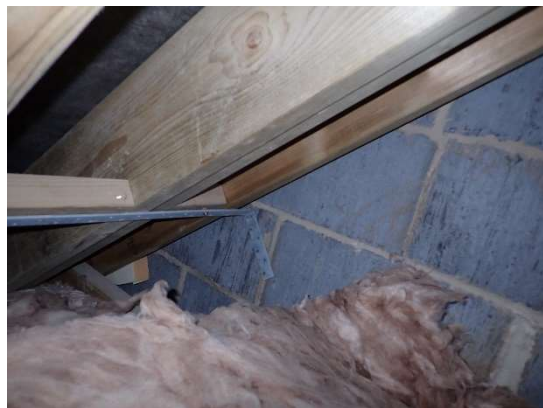
| <i>Item</i> | <i>Location</i> | <i>Description</i> | <i>Defect / Snag</i> | <i>Remedy</i> | <i>Photo</i> |
|---|---|---|---|---|---|
| 1 | Roof Void | Metal restraint straps providing connection between wall and roof structure. | Not embedded or fixed. | Embed, fix and make good. | 1-4 |

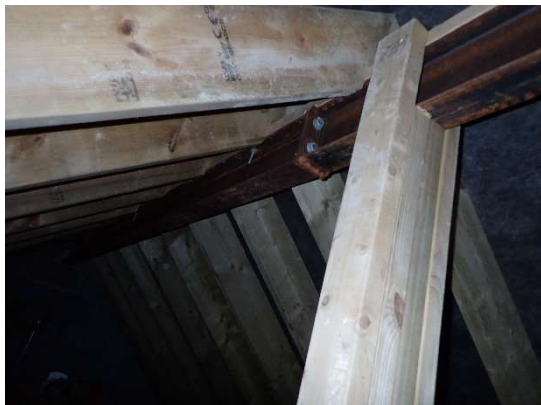
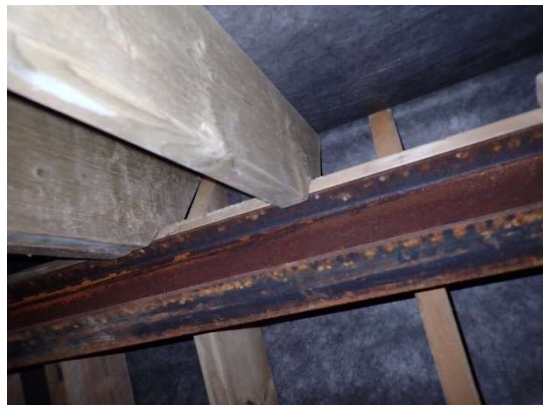
| <i>Item</i> | <i>Location</i> | <i>Description</i> | <i>Defect / Snag</i> | <i>Remedy</i> | <i>Photo</i> |
|---|---|---|---|---|---|
| 1a | Roof Void | Steel ridge beam and support. | <p>Surface corrosion indicates steel has been left exposed for a period of time, no coatings evident.</p> <p>Vertical timber support for beam not over joint of beam.</p> | <p>Rub down and coat with red oxide or similar.</p> <p>Check design and execution is adequate.</p> | 5,6 |

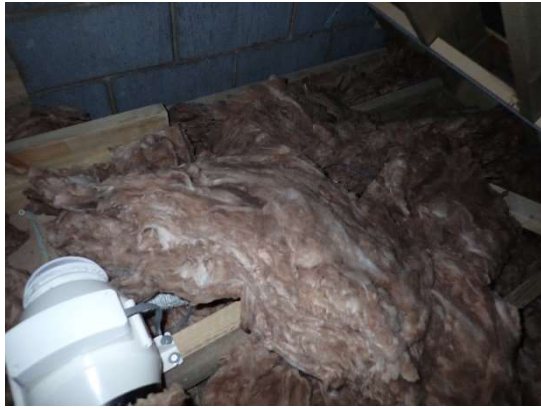
Photo 7

| <i>Item</i> | <i>Location</i> | <i>Description</i> | <i>Defect / Snag</i> | <i>Remedy</i> | <i>Photo</i> |
|---|---|---|---|---|---|
| 2 | Roof Void | Fibreglass insulation at ceiling level. | Haphazardly fitted. | Relay to avoid condensation. | 7 |

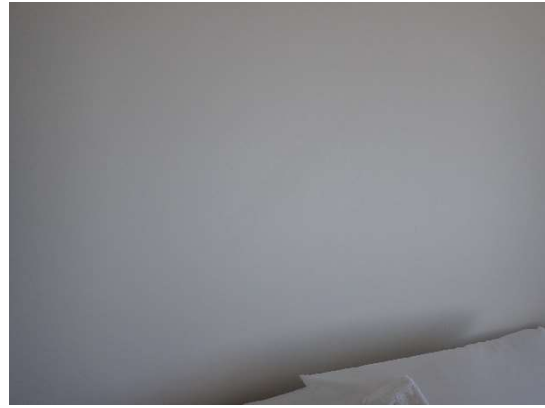
Photo 8

| <i>Item</i> | <i>Location</i> | <i>Description</i> | <i>Defect / Snag</i> | <i>Remedy</i> | <i>Photo</i> |
|---|---|---|---|---|---|
| 4 | Ensuite Bedroom | Decoration. | Marked on South wall. | Make good marks, redecorate. | 8 |

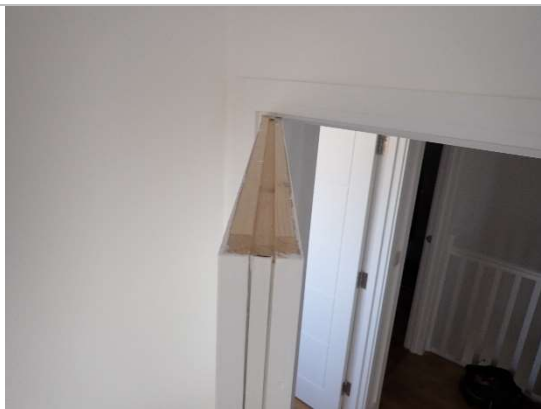
Photo 9

| <i>Item</i> | <i>Location</i> | <i>Description</i> | <i>Defect / Snag</i> | <i>Remedy</i> | <i>Photo</i> |
|---|---|---|---|---|---|
| 3 | Ensuite Bedroom | Fire door. | Missing intumescent strip (top). | Fit strips. | 9 |

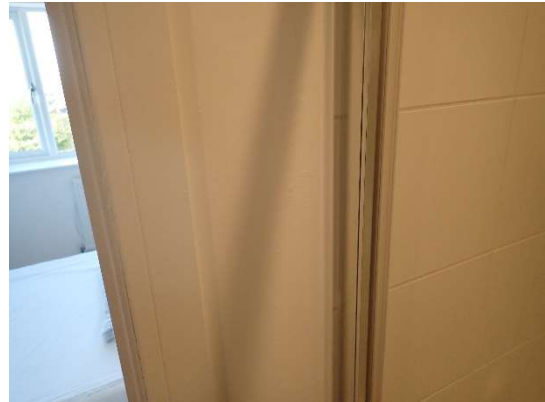
Photo 10

| <i>Item</i> | <i>Location</i> | <i>Description</i> | <i>Defect / Snag</i> | <i>Remedy</i> | <i>Photo</i> |
|---|---|---|---|---|---|
| 5 | Ensuite | Decoration. | Poor finish on partition wall, low level by shower. | Prepare and redecorate. | 10 |

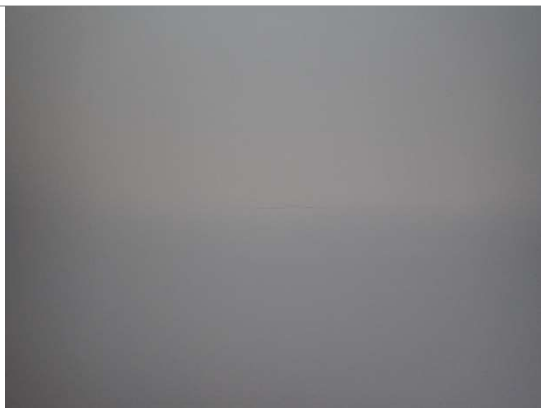
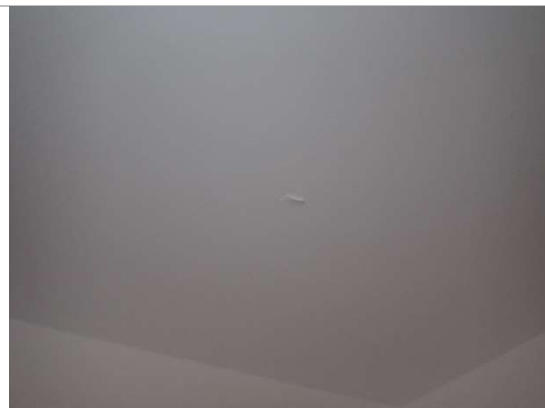
| <i>Item</i> | <i>Location</i> | <i>Description</i> | <i>Defect / Snag</i> | <i>Remedy</i> | <i>Photo</i> |
|---|---|---|---|---|---|
| 9 | Bedroom 2 | Plasterboard ceiling. | Popped nail heads East partition. Cracking on sloping junction West side. | Fill, make good and redecorate. | 10a,<br>10b |

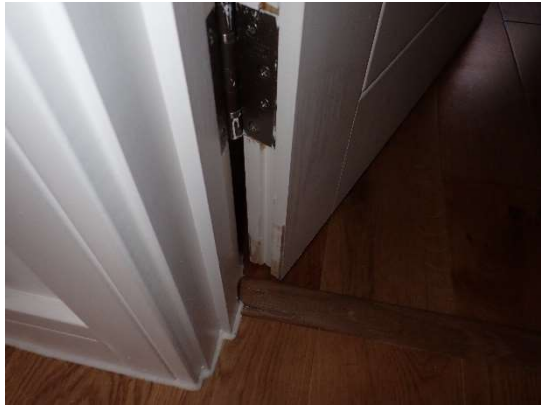
Photo 17

| <i>Item</i> | <i>Location</i> | <i>Description</i> | <i>Defect / Snag</i> | <i>Remedy</i> | <i>Photo</i> |
|---|---|---|---|---|---|
| 10a | Bedroom 3 | Fire door. | Missing intumescent strips | Fit missing strips | 17 |

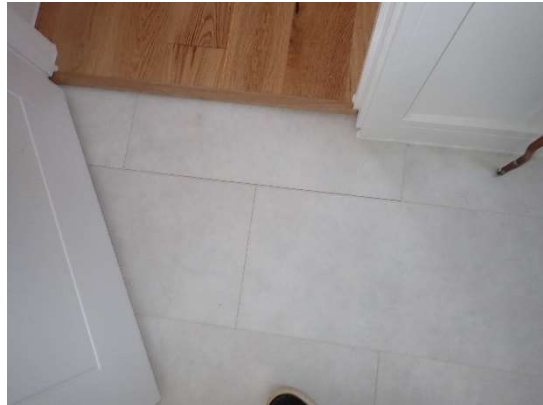
Photo 18

| <i>Item</i> | <i>Location</i> | <i>Description</i> | <i>Defect / Snag</i> | <i>Remedy</i> | <i>Photo</i> |
|---|---|---|---|---|---|
| 11 | Bathroom | Vinyl floor covering. | Poorly laid, gaps in joints, uneven at threshold of door. | Take up poor area and relay. | 18 |

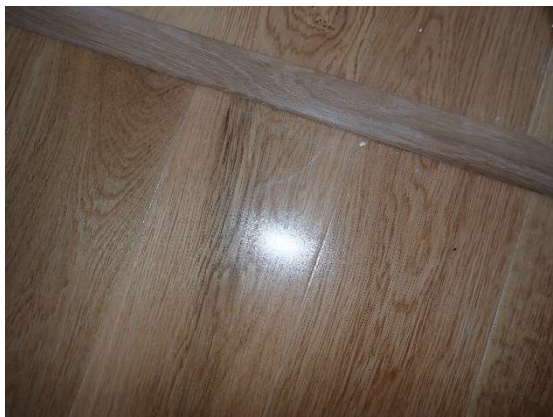
Photo 19

| <i>Item</i> | <i>Location</i> | <i>Description</i> | <i>Defect / Snag</i> | <i>Remedy</i> | <i>Photo</i> |
|---|---|---|---|---|---|
| 6 | Landing | Engineered wood flooring. | Scratched at threshold to Bedroom 2. | Buff out light scratches or fill with putty and make good. | 19 |

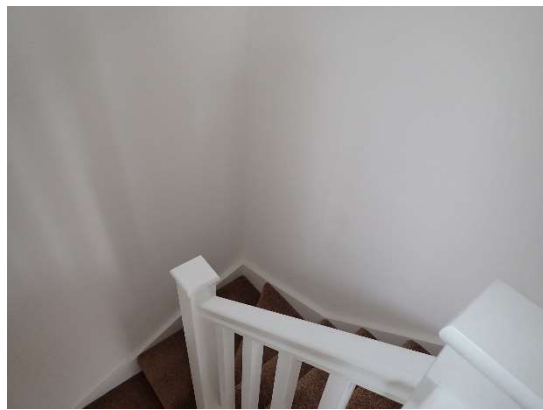
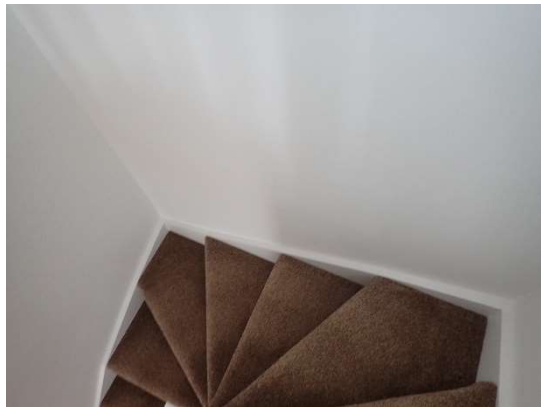
| <i>Item</i> | <i>Location</i> | <i>Description</i> | <i>Defect / Snag</i> | <i>Remedy</i> | <i>Photo</i> |
|---|---|---|---|---|---|
| 8 | Landing / Stairwells | Plasterboard lined walls. | General marks, poor decoration. | Make good and redecorate. | 20,21 |

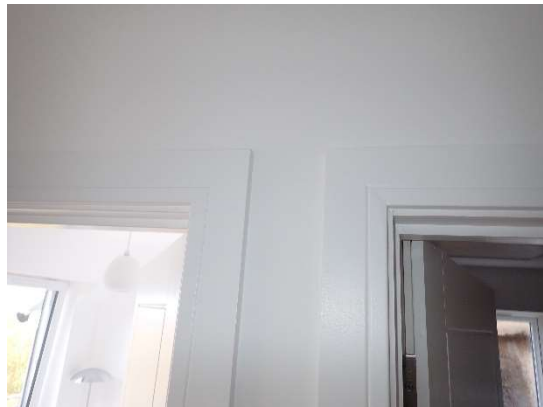
Photo 22

| <i>Item</i> | <i>Location</i> | <i>Description</i> | <i>Defect / Snag</i> | <i>Remedy</i> | <i>Photo</i> |
|---|---|---|---|---|---|
| 7 | Landing | Partition North side. | Shrinkage. | Make good and redecorate. | 22 |

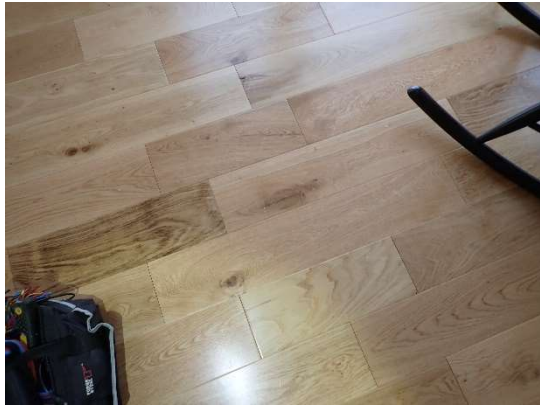
Photo 23

| <i>Item</i> | <i>Location</i> | <i>Description</i> | <i>Defect / Snag</i> | <i>Remedy</i> | <i>Photo</i> |
|---|---|---|---|---|---|
| 18 | Living Room | Engineered wood flooring. | Scratched and marked | Buff out light scratches or fill and make good. | 23 |

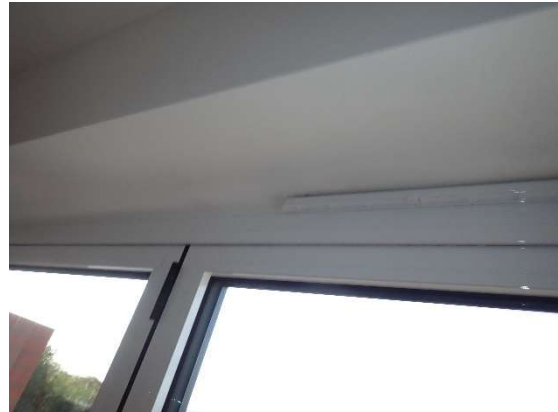
Photo 24

| <i>Item</i> | <i>Location</i> | <i>Description</i> | <i>Defect / Snag</i> | <i>Remedy</i> | <i>Photo</i> |
|---|---|---|---|---|---|
| 17 | Kitchen / Diner | Plasterboard lined walls. | Poor decoration around patio doors. | Make good and redecorate. | 24 |

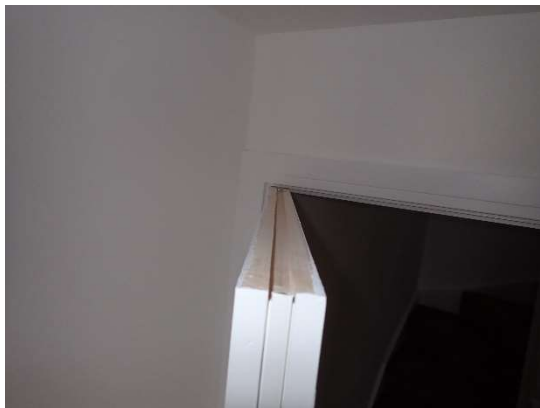
Photo 25

| <i>Item</i> | <i>Location</i> | <i>Description</i> | <i>Defect / Snag</i> | <i>Remedy</i> | <i>Photo</i> |
|---|---|---|---|---|---|
| 13 | Kitchen / Diner | Fire door. | No intumescent strip (top). | Fit missing strip. | 25 |

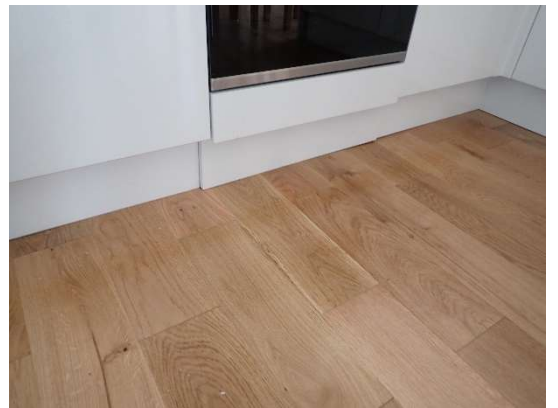
Photo 26

| <i>Item</i> | <i>Location</i> | <i>Description</i> | <i>Defect / Snag</i> | <i>Remedy</i> | <i>Photo</i> |
|---|---|---|---|---|---|
| 15 | Kitchen Fittings | Fitted units. | Marked and damaged worktop. Disturbed plinth under oven. | Replace (understood to have been agreed) / refix. | 26 |

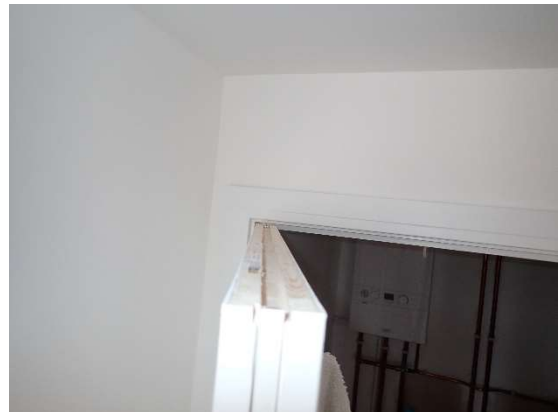
Photo 28

| <i>Item</i> | <i>Location</i> | <i>Description</i> | <i>Defect / Snag</i> | <i>Remedy</i> | <i>Photo</i> |
|---|---|---|---|---|---|
| 14a | Larder | Fire door. | No intumescent strip (top). | Fit missing strip. | 28 |

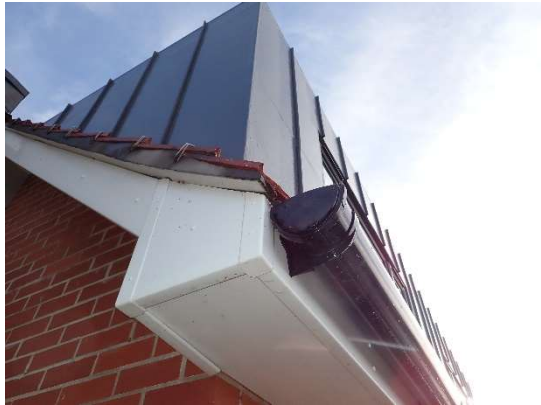
Photo 29

| <i>Item</i> | <i>Location</i> | <i>Description</i> | <i>Defect / Snag</i> | <i>Remedy</i> | <i>Photo</i> |
|---|---|---|---|---|---|
| 27 | Front elevation | Gutter detail. | Large volume of water will run down small area of roof, poor design. Gutter detail does not catch the water. | Realign and extend gutter and / or fit leadwork upstand detail. | 29 |

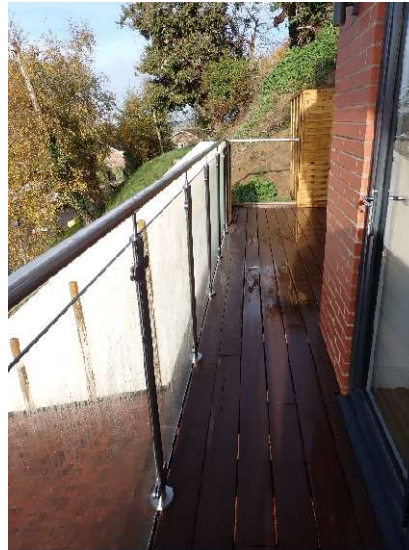
Photo 30

| <i>Item</i> | <i>Location</i> | <i>Description</i> | <i>Defect / Snag</i> | <i>Remedy</i> | <i>Photo</i> |
|---|---|---|---|---|---|
| 32 | Front elevation first floor. | Glass and metal railings | Damaged fitting on North end.<br><br>Flexing hand and guardrail. | Replace damaged area and ensure glazing secured.<br><br>Ensure fitted to manufacturers standards. | 31,32<br><br>30 |

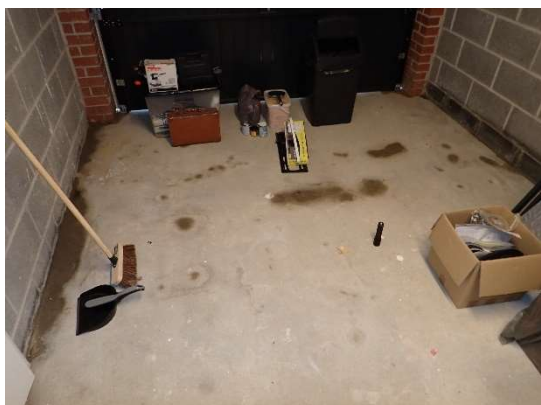
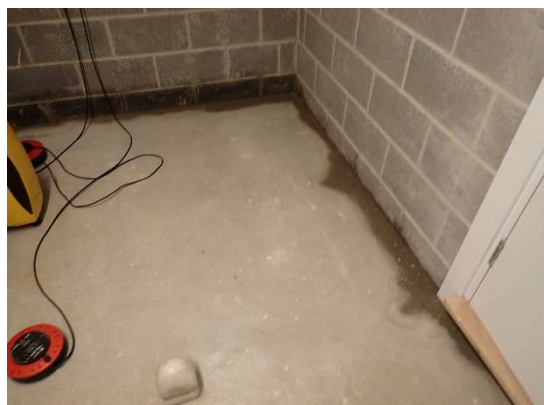
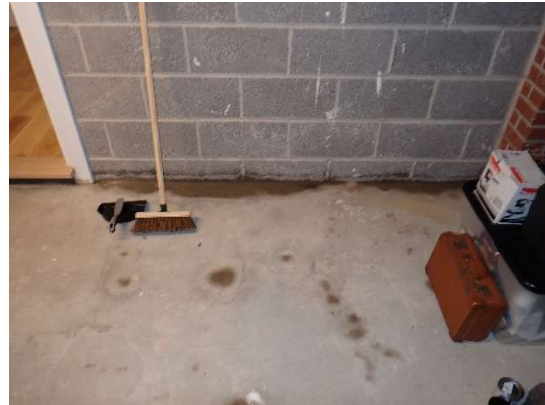
| <i>Item</i> | <i>Location</i> | <i>Description</i> | <i>Defect / Snag</i> | <i>Remedy</i> | <i>Photo</i> |
|---|---|---|---|---|---|
| 26 | Garage | Blockwork walls, concrete floor, damp proofing. | Damp roof course higher than internal slab. No link between dpm in floor and dpc in walls. Dampness in walls and floors, affecting habitable spaces, Hall and understairs. | Further investigation of damp proofing detailing , inc. external. See additional comments. | 33-35, 38, 40,50-52 |

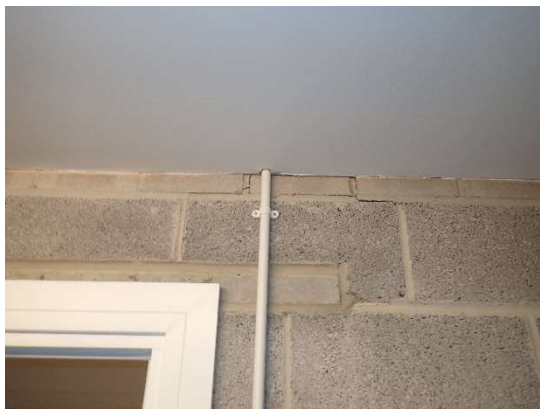
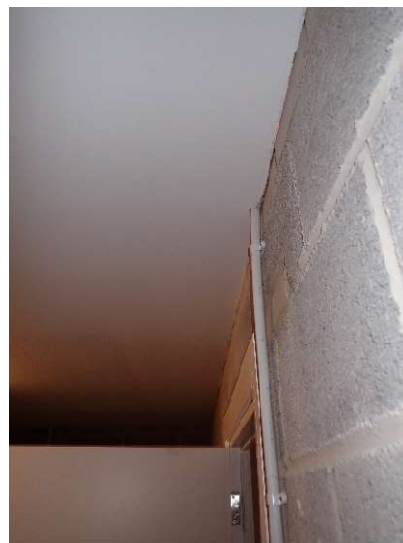
| <i>Item</i> | <i>Location</i> | <i>Description</i> | <i>Defect / Snag</i> | <i>Remedy</i> | <i>Photo</i> |
|---|---|---|---|---|---|
| 25 | Garage | Ceiling. | Gaps between wall and ceiling perimeter (fire protection). | Seal with intumescent sealant and make good. | 36,37 |

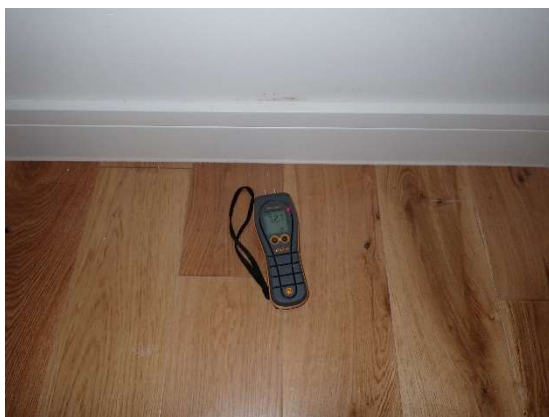
Photo 38

| <i>Item</i> | <i>Location</i> | <i>Description</i> | <i>Defect / Snag</i> | <i>Remedy</i> | <i>Photo</i> |
|---|---|---|---|---|---|
| 21 | Hall | Plasterboard lined wall and skirting board. | High moisture in lining and skirting board. | Further investigation of damp proofing detailing. | 38 |

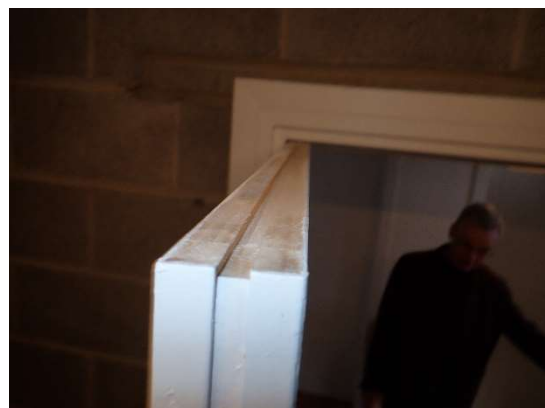
Photo 39

| <i>Item</i> | <i>Location</i> | <i>Description</i> | <i>Defect / Snag</i> | <i>Remedy</i> | <i>Photo</i> |
|---|---|---|---|---|---|
| 26a | Garage | Fire door. | No intumescent strip (top). | Fit missing strip. | 39 |

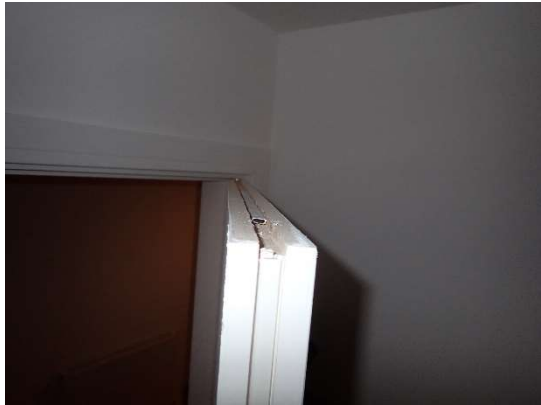
Photo 44

| <i>Item</i> | <i>Location</i> | <i>Description</i> | <i>Defect / Snag</i> | <i>Remedy</i> | <i>Photo</i> |
|---|---|---|---|---|---|
| 24 | Study | Fire door. | No intumescent strip (top). | Fit missing strip. | 44 |

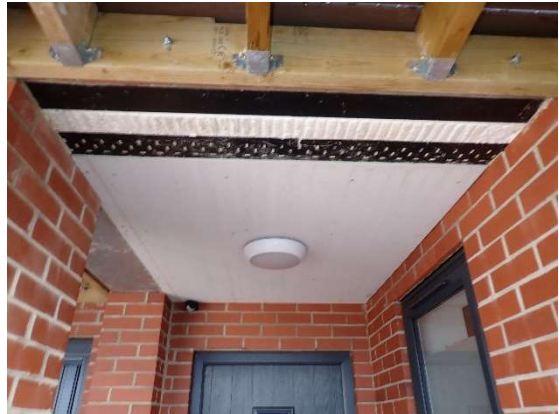
Photo 45

| <i>Item</i> | <i>Location</i> | <i>Description</i> | <i>Defect / Snag</i> | <i>Remedy</i> | <i>Photo</i> |
|---|---|---|---|---|---|
| 29a | Front elevation | Porch under balcony. | Exposed support, no fire protection and unfinished. | Complete fire rated linings. | 45 |

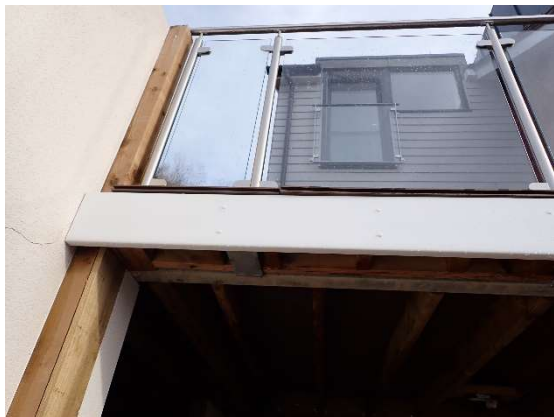
Photo 46

| <i>Item</i> | <i>Location</i> | <i>Description</i> | <i>Defect / Snag</i> | <i>Remedy</i> | <i>Photo</i> |
|---|---|---|---|---|---|
| 30a | Front elevation | Decking on North end. | Uneven, at edge. | Realign and make good. | 46 |

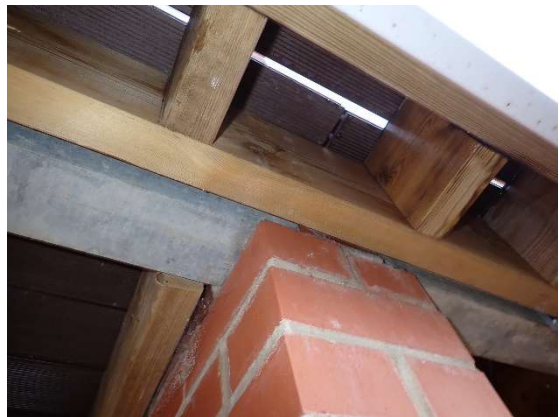
Photo 47

| <i>Item</i> | <i>Location</i> | <i>Description</i> | <i>Defect / Snag</i> | <i>Remedy</i> | <i>Photo</i> |
|---|---|---|---|---|---|
| 30b | Decking | Metal frame support. | Bearing on brick minimal. | Check specification and detail. | 47 |

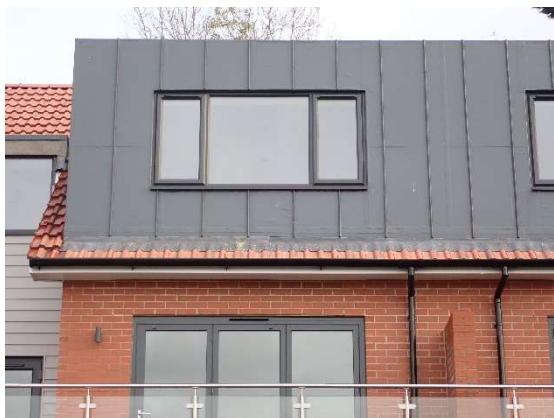
Photo 48

| <i>Item</i> | <i>Location</i> | <i>Description</i> | <i>Defect / Snag</i> | <i>Remedy</i> | <i>Photo</i> |
|---|---|---|---|---|---|
| 29b | Front elevation | Dormer with seamed single ply covering. | Bubbled up areas of surface. | To be monitored, check guarantees. | 48 |

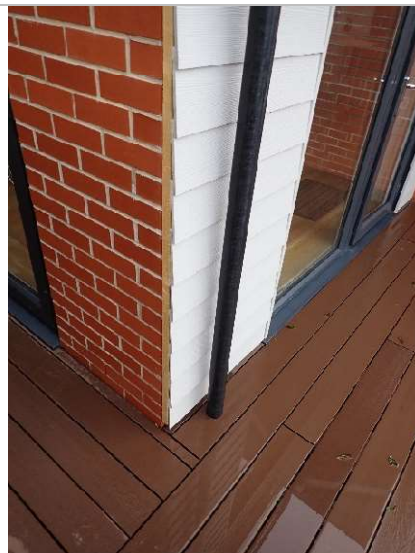
Photo 49

| <i>Item</i> | <i>Location</i> | <i>Description</i> | <i>Defect / Snag</i> | <i>Remedy</i> | <i>Photo</i> |
|---|---|---|---|---|---|
| 29 | Front Elevation | Cladding. | No capping detail at junction of roof and first floor level. Water ingress and decay risk. | Fit manufacturer cappings and make good, or fashion detail. | 49 |

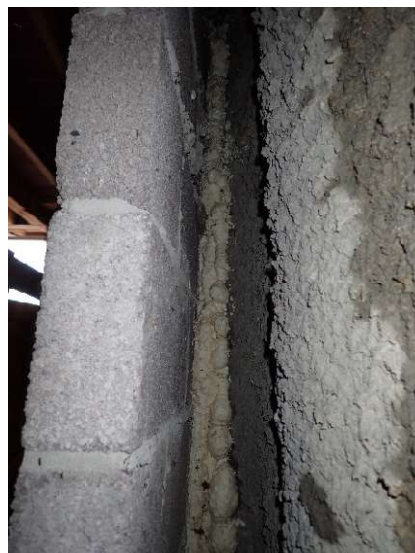
Photo 53

| <i>Item</i> | <i>Location</i> | <i>Description</i> | <i>Defect / Snag</i> | <i>Remedy</i> | <i>Photo</i> |
|---|---|---|---|---|---|
| 35 | North end of site | Blockwork wall against retaining structure. | Expanding foam filled, no inspection possible. | Confirmation of any tying in of structures | 53 |

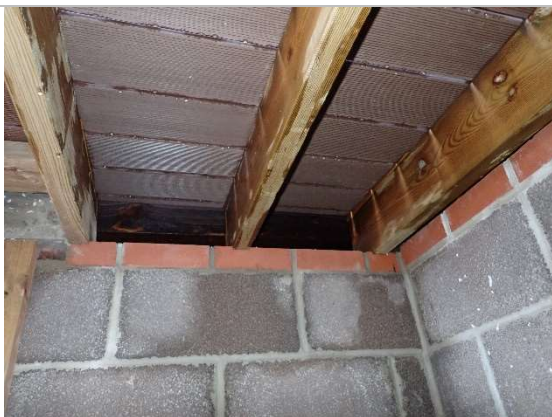
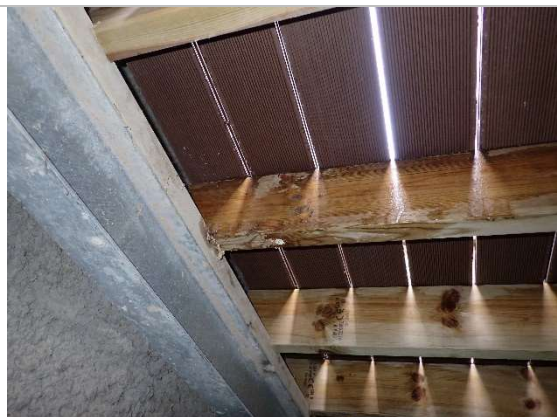
| <i>Item</i> | <i>Location</i> | <i>Description</i> | <i>Defect / Snag</i> | <i>Remedy</i> | <i>Photo</i> |
|---|---|---|---|---|---|
| 30 | Decking / Bin store | Open composite decking with timber support on metal frame. | Timbers wetted due to design will increase decay risks, failure and higher repair and renewal obligation to keep safe. | High maintenance potential | 54,55 |

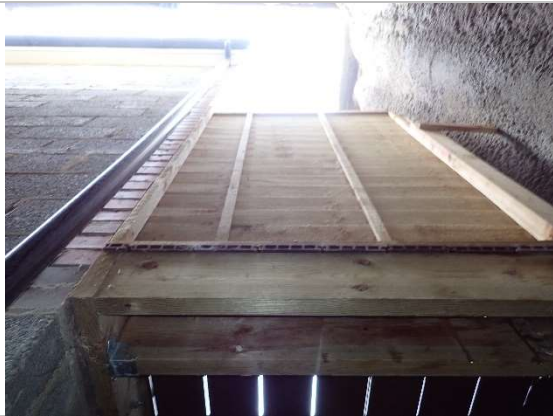
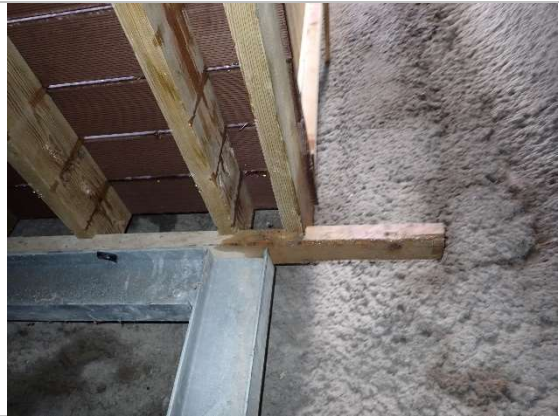
| <i>Item</i> | <i>Location</i> | <i>Description</i> | <i>Defect / Snag</i> | <i>Remedy</i> | <i>Photo</i> |
|---|---|---|---|---|---|
| | | Fence and plate detail | Stored bins / recycling gets wet due to design.<br><br>Incomplete and high maintenance potential. | Cover to protect, allow for discharge of water. | 56,57 |

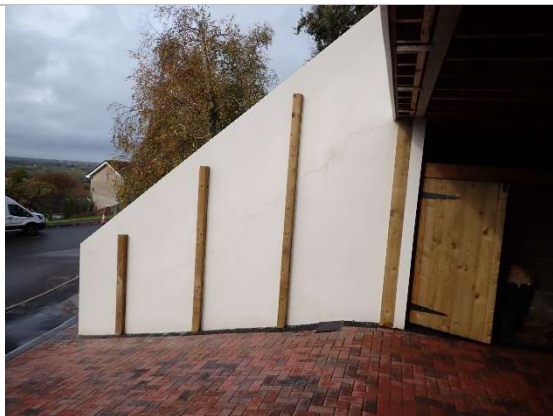
Photo 58

| <i>Item</i> | <i>Location</i> | <i>Description</i> | <i>Defect / Snag</i> | <i>Remedy</i> | <i>Photo</i> |
|---|---|---|---|---|---|
| 36 | Retaining wall between steps and driveway. | Rendered retaining wall. | Crack at junction of wall and steps. | Cut out channel, lathe and render or replace. | 58 |

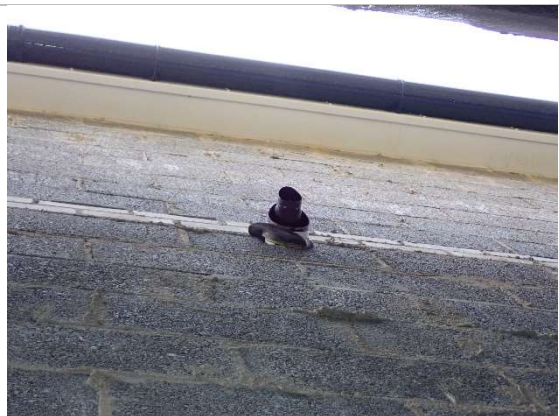
Photo 59

| <i>Item</i> | <i>Location</i> | <i>Description</i> | <i>Defect / Snag</i> | <i>Remedy</i> | <i>Photo</i> |
|---|---|---|---|---|---|
| 31 | Rear elevation | Boiler flue collar. | Collar not fitted around flue and opening properly. | Ensure collar fitted and secure as intended. (Gas Safe Engineer.) | 59 |

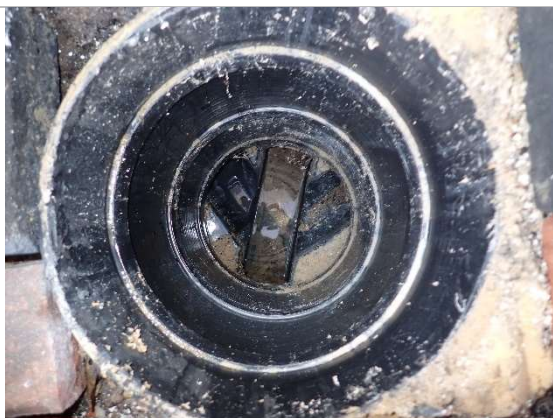
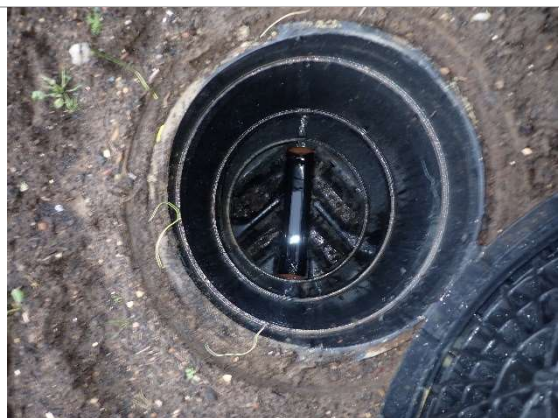
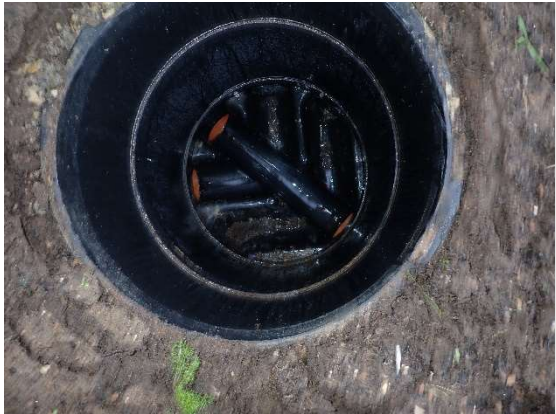
| <i>Item</i> | <i>Location</i> | <i>Description</i> | <i>Defect / Snag</i> | <i>Remedy</i> | <i>Photo</i> |
|---|---|---|---|---|---|
| 34 | Front of site | Inspection chambers | Lying water in chamber on North end.<br><br>Loose frame to chamber. | Investigate fall / blockage.<br><br>Secure frame. | 60<br><br>61,62 |

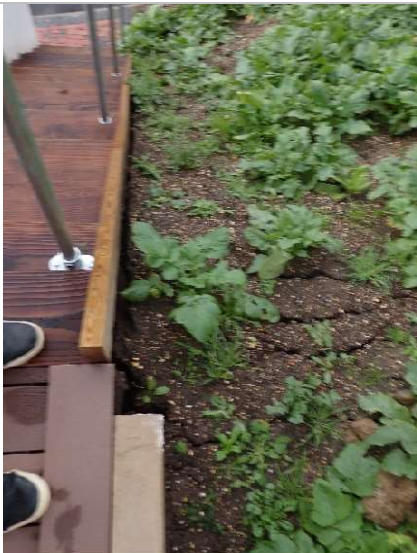
| <i>Item</i> | <i>Location</i> | <i>Description</i> | <i>Defect / Snag</i> | <i>Remedy</i> | <i>Photo</i> |
|---|---|---|---|---|---|
| | North end of site / boundary with steps. | Made up ground. | Made up ground slipping. | Confirm ownership and plans for stabilising. | 63 |

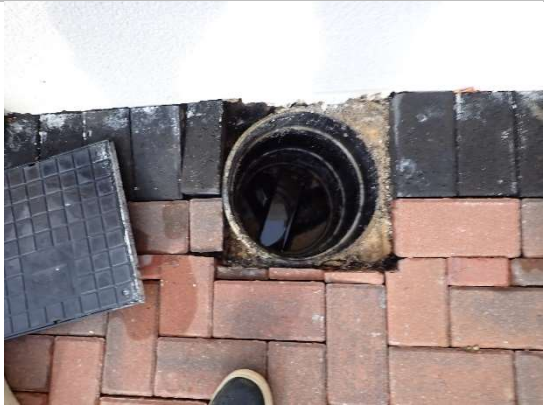
| <i>Item</i> | <i>Location</i> | <i>Description</i> | <i>Defect / Snag</i> | <i>Remedy</i> | <i>Photo</i> |
|---|---|---|---|---|---|
| 33 | Front drive | Brick detail. | Disturbed on North end by inspection chamber. | Make good. | 64 |
