# SNAGGING INSPECTION

1 Levels View, Rowley Road, Glastonbury BA6 8HY

DATE OF INSPECTION: 16<sup>th</sup> November 2022

REFERENCE NUMBER: 7468W

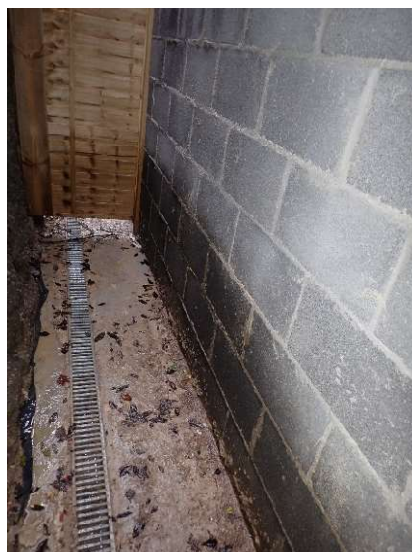
*Visible affects of dampness round the perimeter of the Garage*

The damp proof course installed horizontally and visible in the wall is satisfactorily above external ground level (approximately 150mm). Externally, a minimum fall to the ground level and aco drain to aid surface water drainage has also been fitted.

However, the concrete slab appears to have been laid at the same level as the external ground, with no apparent lapping of the damp proof membrane in the floor with the damp proof course in the wall. This is causing penetrating dampness to occur, affecting wall, floor and internal finishes to the habitable areas on the ground floor.

This visible defect raises suspicion that the relationship of floor and ground levels and poor and lack of damp roofing detailing will be found across the whole ground floor. It is advised to invasively inspect those areas which shows signs of dampness to confirm if similar problems are occurring.

It is suspected that a comprehensive scheme of works to address the problems found will be required. The design to adequately damp proof, reinstate insulation and slab and retain a step down into the Garage will be limited by the reinforced raft foundation below and must be considered before any works commence.
